# Coastal Management Study

# Longshore Drift & Sand Dunes

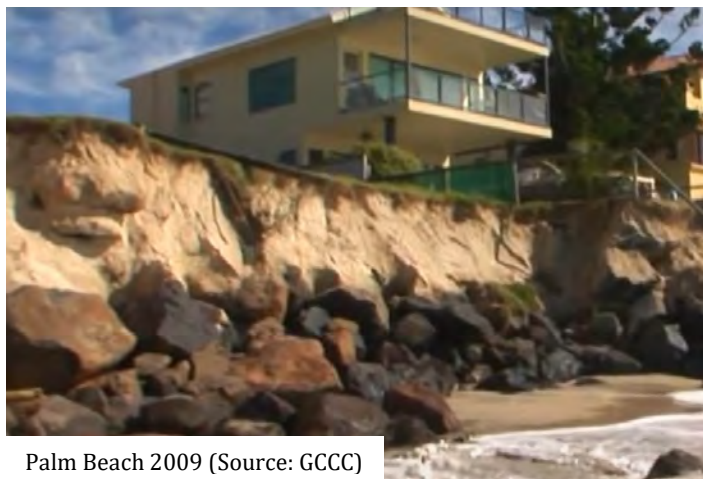
Palm Beach 2009 (Source: GCCC)

A long history of beachfront development has led to the destruction of the dune system and stabilising vegetation along Palm Beach. Limited protection against erosion, coupled with the fact that it is one of the most easterly beaches on the Gold Coast, means that it is regularly at risk of severe erosion.

In 2019, an artificial reef was constructed in an attempt to protect and stabilise Palm Beach.

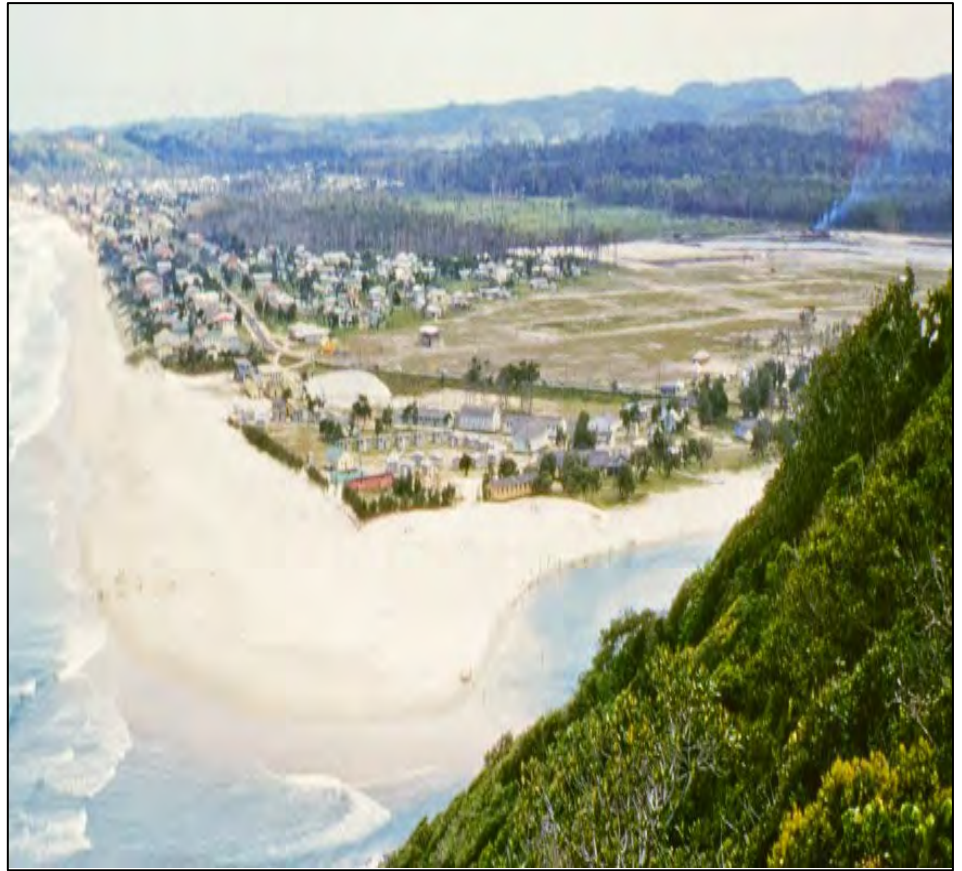
**Tallebudgera Creek (1960)**

In the mid-1970s, the Gold Coast City Council (GCCC) began to build a rock training wall on the southern side of the Tallebudgera Creek mouth, extending the wall 300m towards the ocean. This training wall was built for three important reasons:

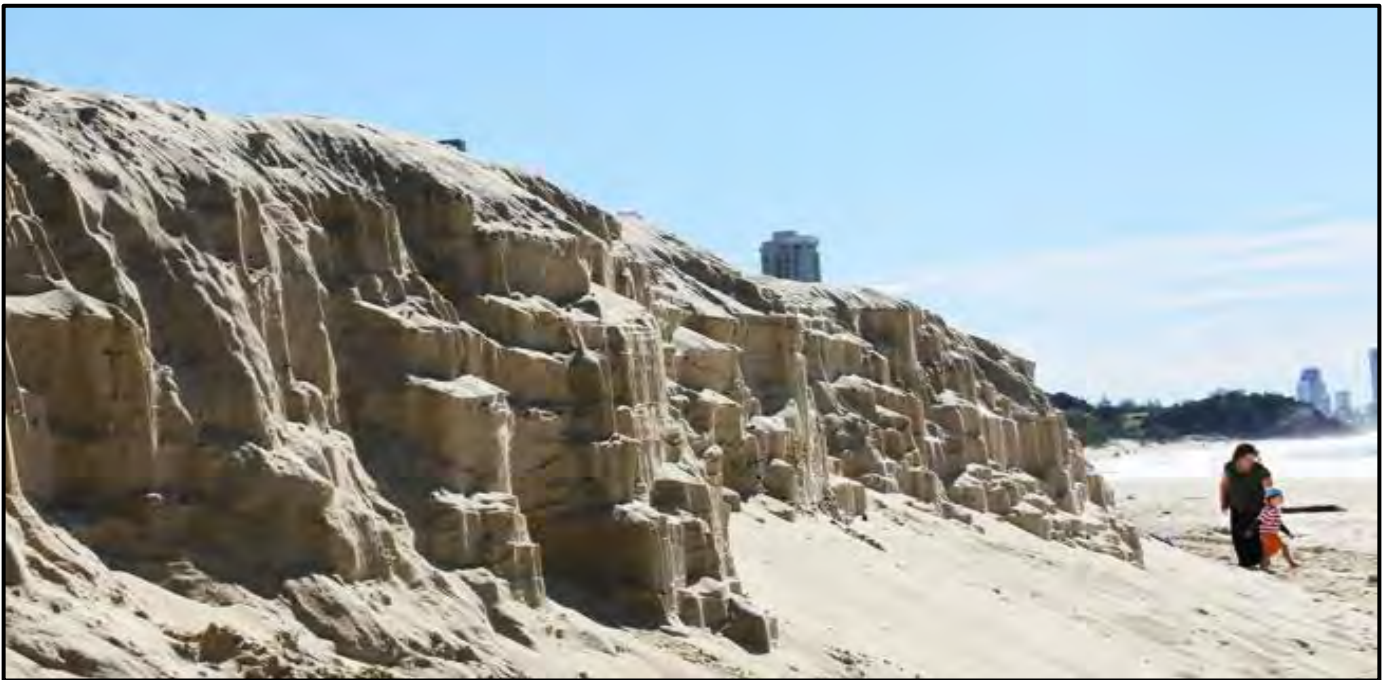
### **Erosion escarpments at Burleigh Beach 2013**

Following the completion of the Tallebudgera Creek training wall, Gold Coast residents found that Burleigh Beach, Surfers Paradise and other beaches further north were eroding more than normal. The once-beautiful sandy beaches of the Gold Coast were narrowing quickly and storm events left ugly cliffs and escarpments on the beaches. Upon further investigation, the Gold Coast City Council (GCCC) found that as a result of the installation of the training walls at Tallebudgera Creek, Currumbin Creek, and Tweed Heads, longshore drift was being interrupted and not enough sand was travelling north to restore Burleigh and the northern beaches from erosion.

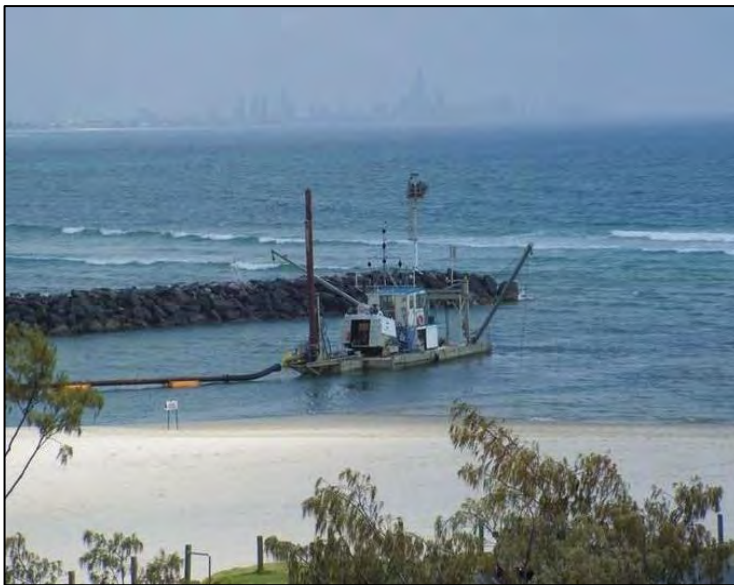
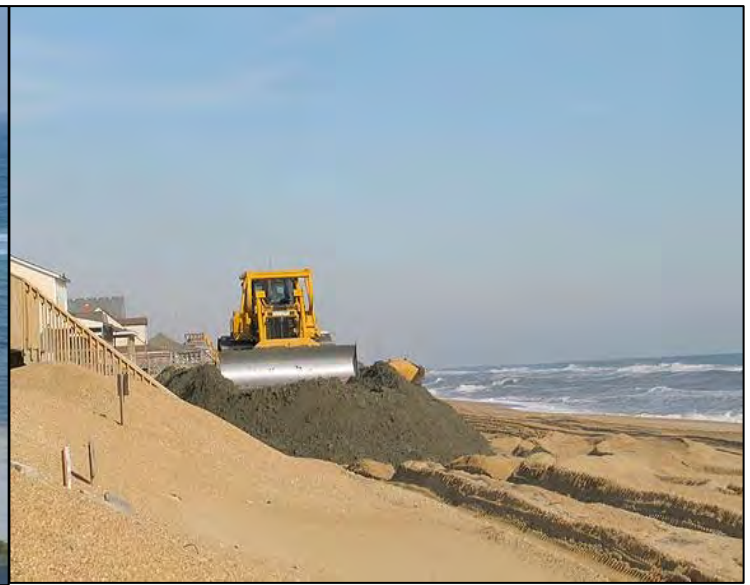
### **Dredging, sand pumping and beach replenishment**

Beginning in the 1990s, the GCCC implemented annual sand dredging and pumping at Tallebudgera Creek, taking sand from the creek mouth and offshore and pumping it onto Burleigh Beach in an effort to reduce the coastal erosion and reinstate longshore drift to the northern beaches.

The amount of sand dredged from the creek varies each year – it depends on how much sand has filled up in the creek and how much erosion has occurred at Burleigh Beach. The amount of sand dredged ranges between 20,000 and 100,000 cubic meters. In 2013, 35,814 cubic meters of sand was dredged and pumped onto Burleigh Beach, costing \$303,151 (or about \$8.50 per m<sup>3</sup>).

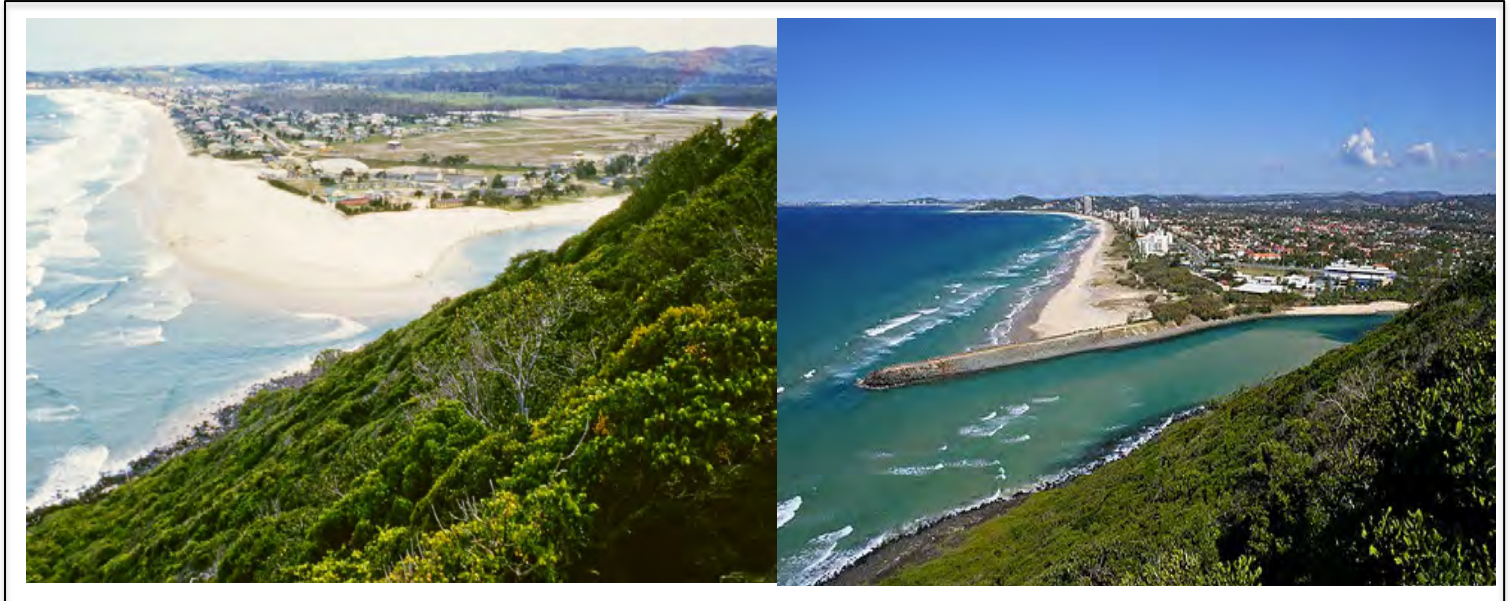
Compare and contrast Tallebudgera Creek between 1960 (left) and 2015 (right).

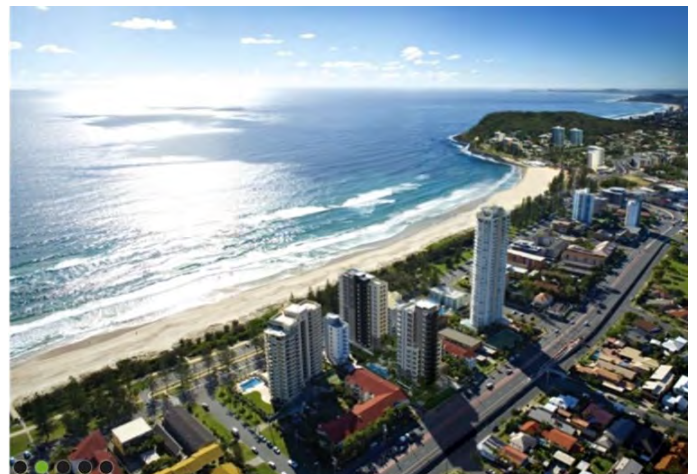
**Burleigh Beach Development**

Despite all the changes to Burleigh Beach, it continued to be a popular tourist attraction and businesses began to grow. *The Esplanade* (the main road behind Burleigh Beach) became a bustling street, and more people moved into the area to live. Residential development boomed and property prices began to increase as people sought to live closer and closer to the ocean. Over time, houses began to be replaced with apartments and units, until today where the Burleigh Heads is a high-density suburb with nearly 10,000 residents.

More frequent storm events associated with global warming, together with the interruption of longshore drift and the destruction of dune systems, causes Burleigh Beach to frequently become disfigured with steep erosion cliffs and beach sand loss.

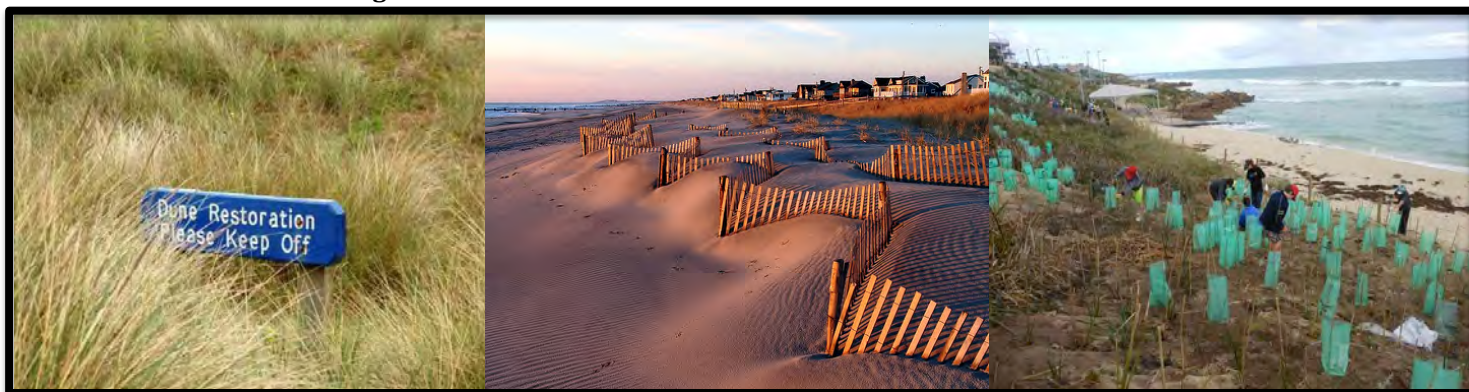
### Dune rehabilitation and revegetation

One management strategy that can help mitigate the problems of storm events and erosion is dune rehabilitation and revegetation. Without sand dunes and their stabilising vegetation, beaches are unable to hold onto sand, and the resulting erosion problems are severe. Creating a dune system on a beach and helping stabilise it with littoral species can significantly improve a beach's ability to retain sand and recover more rapidly from erosion. This method is not quick (it can take decades to fully establish the vegetation on the dunes) and is expensive (especially regarding maintenance), but the long-term results from it can significantly reduce the need for sand pumping and training walls and return the beach system very close to stability.
